Evaluation of the Jotun Hull Skating Solution: A Proactive Ship Biofouling In-Water Cleaning System

5 September 2022

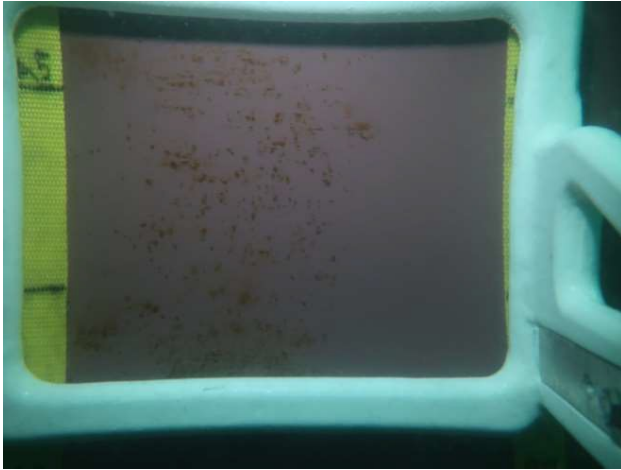
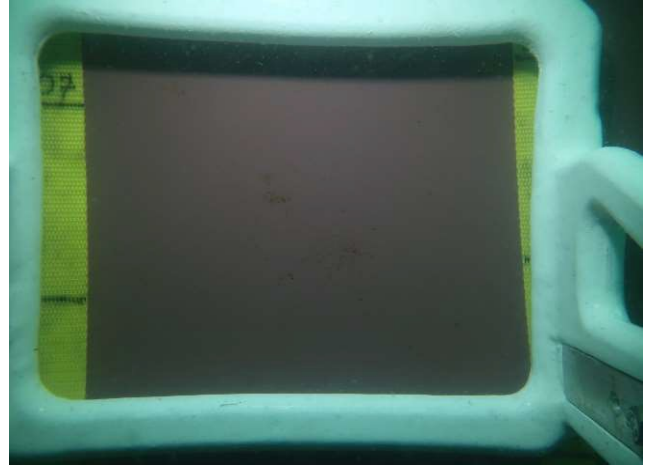
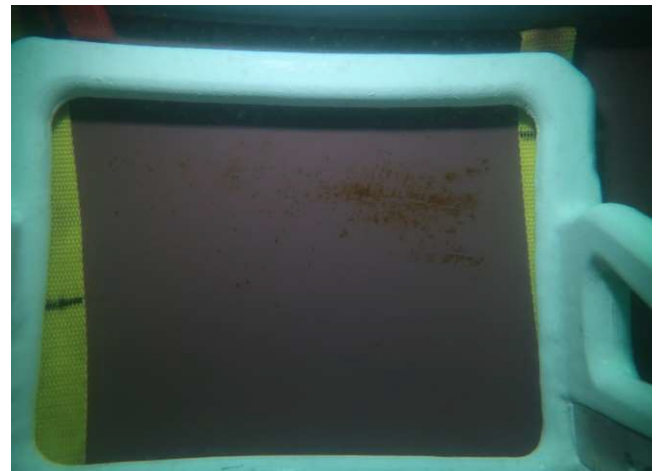
Figure 4. Pictures from the second photo survey in March 2022. A) flat untreated, B) flat treated, C) Curved untreated, and D) curved treated. The brown coloration is biofilm present on the hull, FR 20 or less.

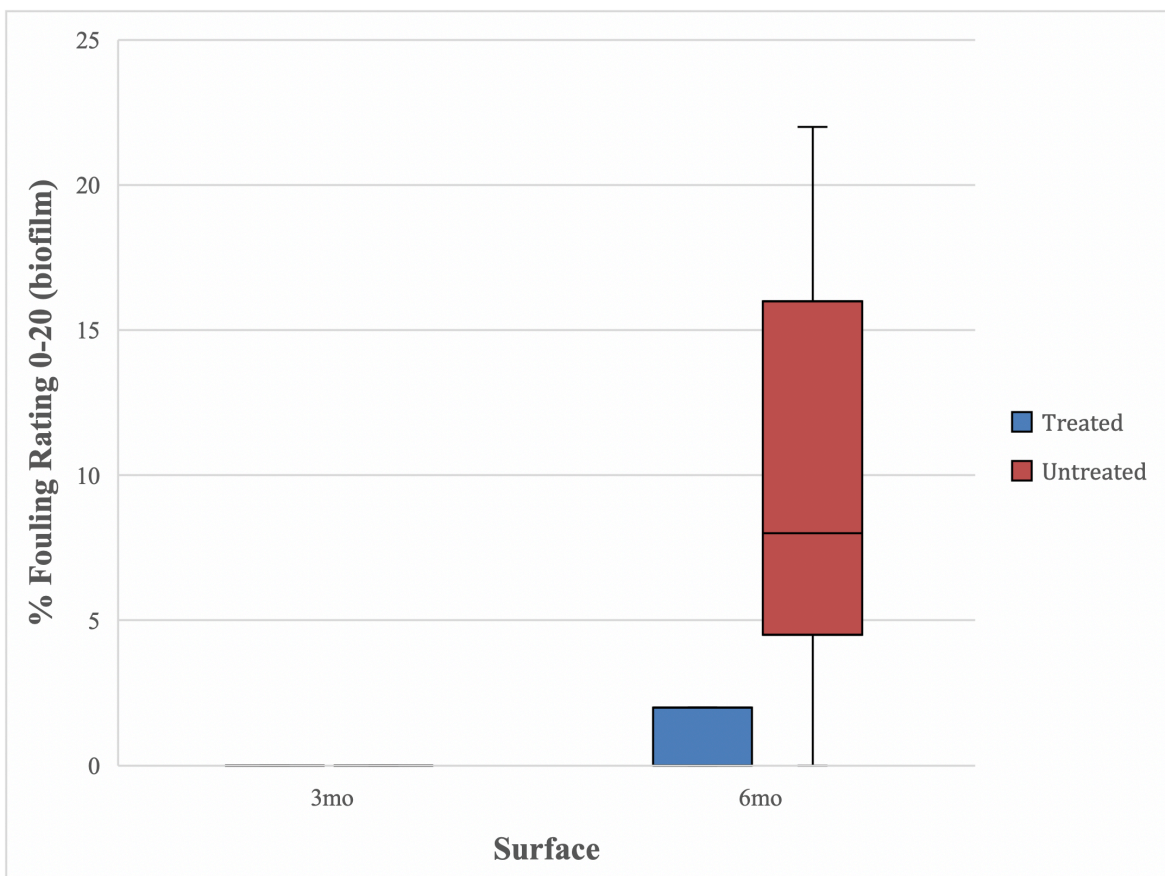
Figure 5. Frequency of fouling rating 0-20 (biofilm) observed on the vessel hull during the initial (3 mo) and second (6 mo) survey. No heavier fouling (e.g. macrofouling) was observed in either treated or untreated samples and at either time point. Error bars show the lowest and highest data points (n=6); median value is also indicated.

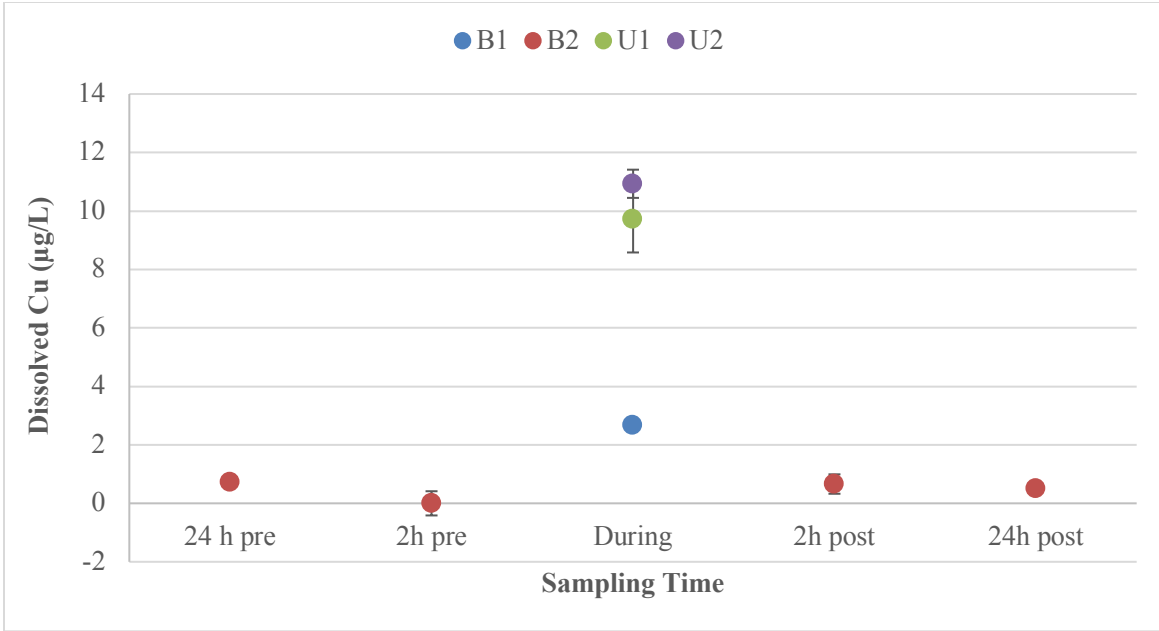
Figure 7. Time series of dissolved copper data. The 95% confidence (CI) intervals are shown in the error bars. The 95% CI for some stations were too low to display on the graph. Stations shown at or below 0 are BQL. The detection limits are shown in Table 9.

Elevated levels of coating associated biocides were measured around the HSS cleaning unit, both during cleaning and when stationary on the side of the test ship, during the one water quality test trial.

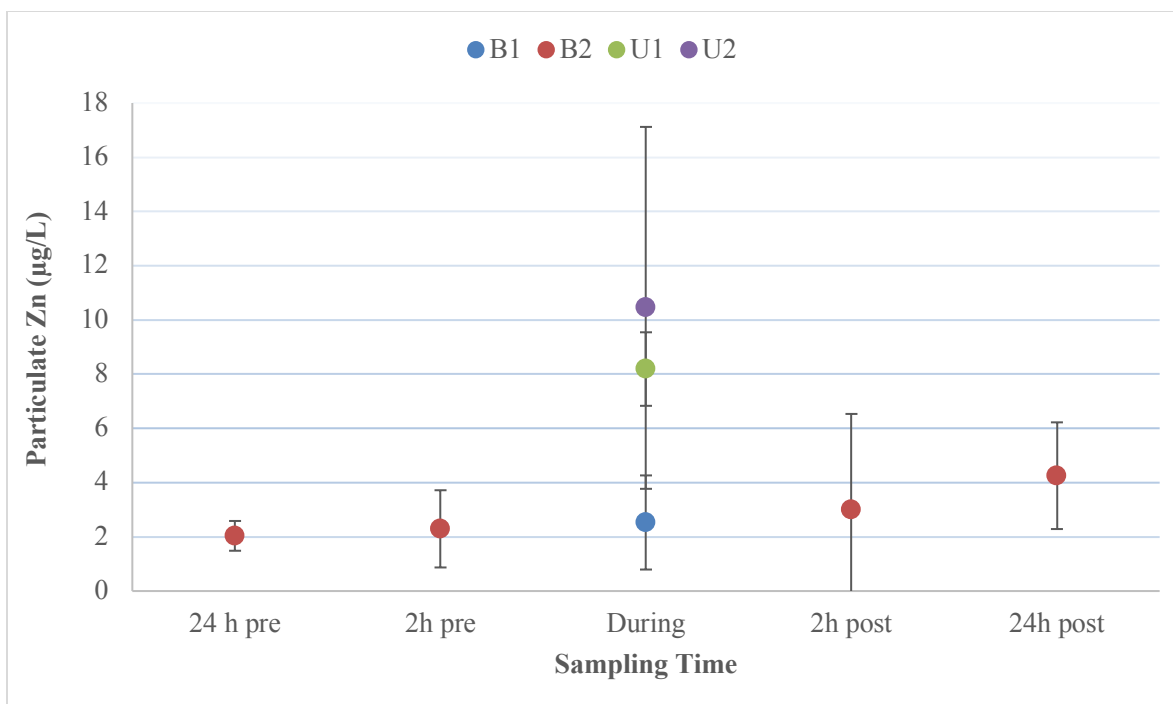
Figure 10. Time series of particulate zinc data. The 95% confidence (CI) intervals are shown in the error bars. The 95% CI for some stations were too low to display on the graph. The detection limits are shown in Table 9.
